# VITA Denture Teeth

Technical and scientific documentation

Date of issue: 2023-02

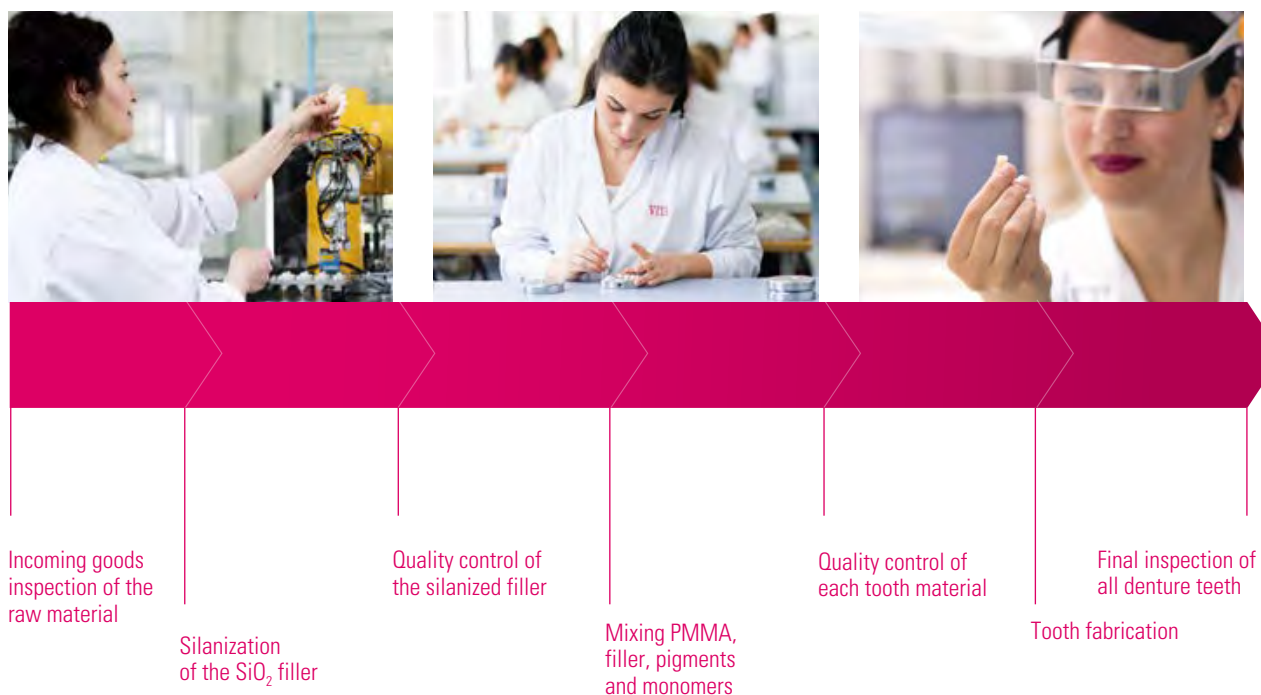
Figure 9: Manufacturing process of VITA denture teeth; source VITA R&D

MRP composite is manufactured under constant quality control, according to a procedure developed in-house at VITA Zahnfabrik. VITA denture teeth, made from MRP composite, are manufactured exclusively in southern Germany at the headquarters of VITA Zahnfabrik, according to the highest production and quality standards – ensuring consistently reliable prosthetics. Specially trained, skilled personnel produce the denture teeth using automated processes, as well as customized manual production. Figure 9 shows the general process from receiving the raw materials to finished denture tooth.

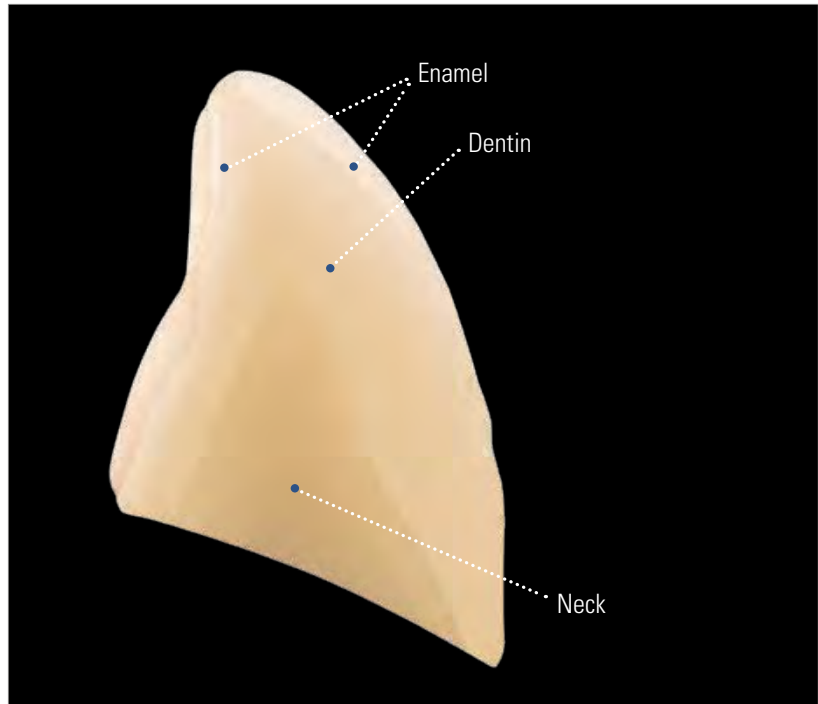
Figure 10: Schematic layering of VITAPAN EXCELL®

Today, high-quality denture teeth are built up layer-by-layer from different types of material. A natural shade effect and translucency of the denture teeth can be achieved by varying the material composition (e.g., filler content, pigments or monomers). The layering of a new generation tooth is shown using the example of VITAPAN EXCELL® (Fig. 10).

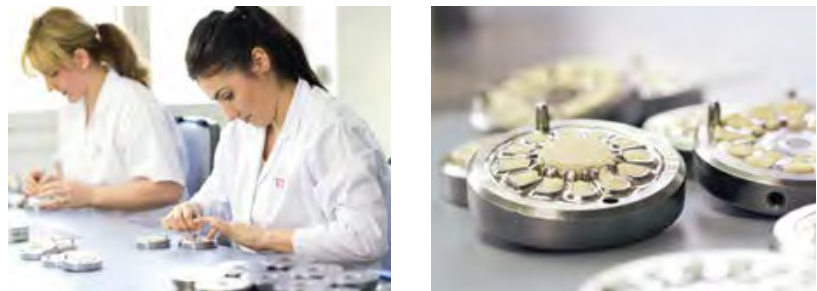
Insert enamel, dentin and cervical material, close mould

Polymerization under the influence of heat and increasing pressure

**Figure 11a:** Schematic representation of the manufacturing procedure of denture teeth made from MRP composite; source VITA R&D

With VITA denture teeth made from MRP composite, the different shaded materials for enamel, counter mould enamel, dentin and cervical area are packed successively into the tooth mould. The mould is only closed when it is completely filled with material. The material is compressed and cured under the influence of pressure and heat in a special heating press. The denture tooth is completely polymerized in a single step. During polymerization, the marginal layers of the individual materials interlock, resulting in a gap-free and porous-free bond (Fig. 11b)

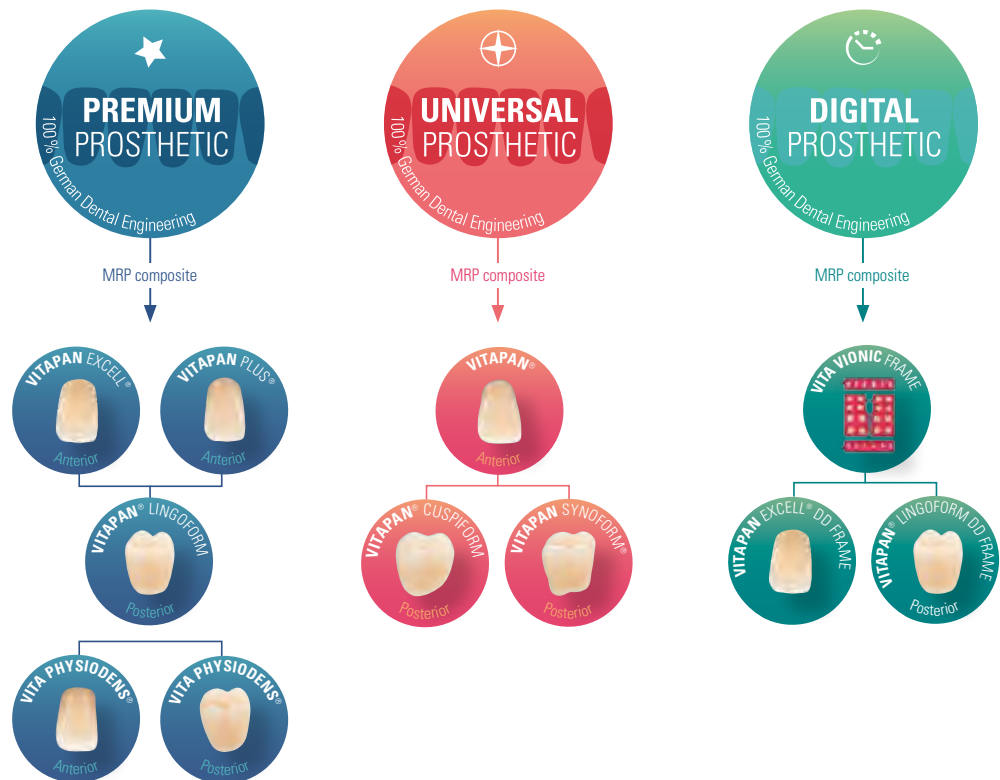
Figure 13: Illustration of the VITA MRP composite anterior/posterior range structure

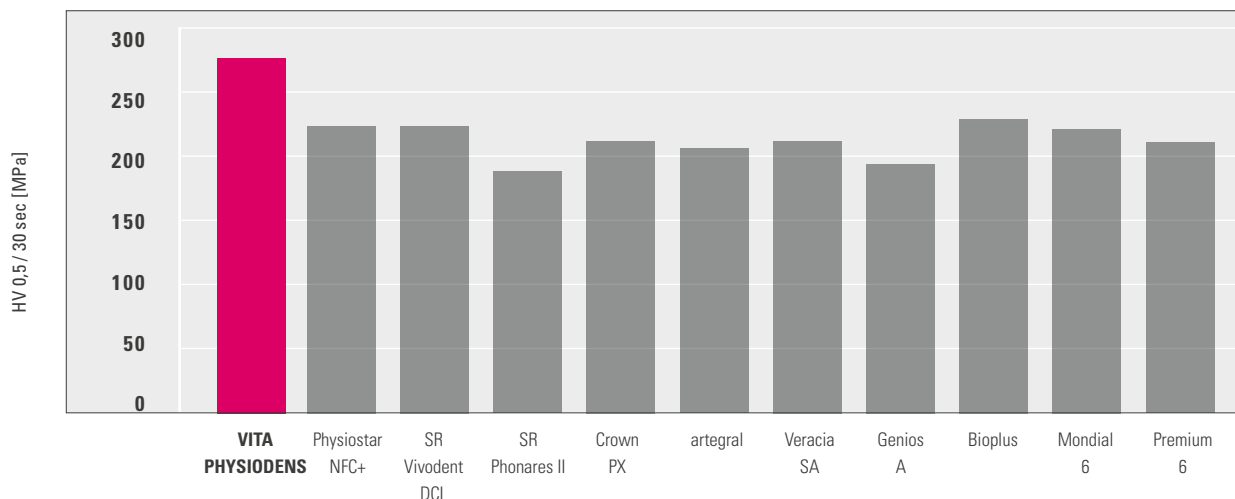
#### Vickers hardness (HV)

One denture tooth from each of the tooth lines below was cut through the middle and one half each embedded in epoxy resin and then polished to a high luster. Three hardness indentations were applied to each polished tooth section in the test machine using a testing force of 5 Newton (N) for 30 seconds. After measuring the indentation diagonals, the hardness was calculated in megapascals (MPa). This test was carried out in accordance with ISO 6507-1. The result graph shows the mean values from the three measurements for each tooth line.

Representing all VITA denture teeth made from MRP composite, VITA PHYSIODENS® showed the highest mean value in the Vickers hardness test. The mean Vickers hardness values calculated for individual tooth lines built up from different materials may vary by approx. 25 percent, depending on the layer of material. With VITA tooth lines made from MRP composite, all layers consist of this special composite. The test results achieved with VITA MRP composite denture teeth show a high mechanical resistance.

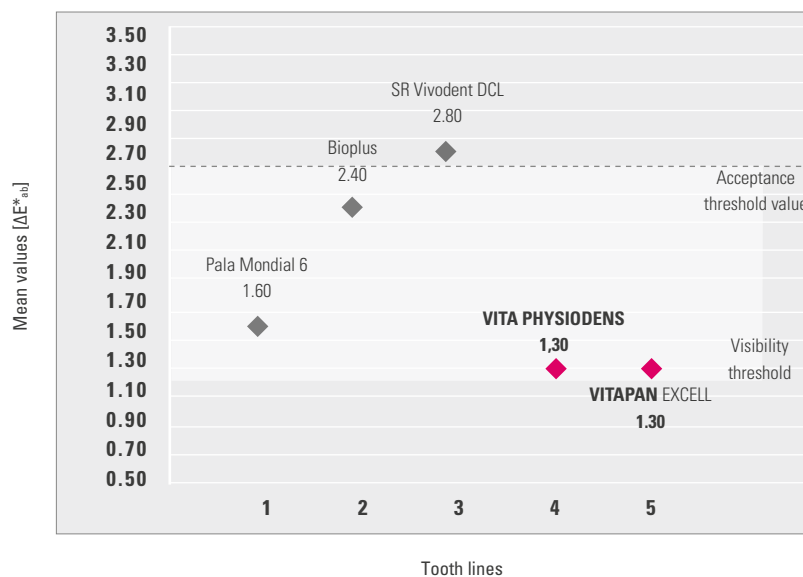
#### Shade match of the tooth lines to the VITA classical A1–D4® shade standard

Overall mean values ( $\Delta E^*_{ab}$ ) for each tooth line (all sets of teeth in A1, A2, A3)

The test results indicate that the VITAPAN EXCELL® and VITA PHYSIODENS® anterior teeth tested, exhibit on average, an excellent shade match to the VITA classical A1–D4® in shades A1, A2, A3. A mean of  $\Delta E^*_{ab}$  1.3 was determined from all measurements (A1, A2 and A3) for each of the two tooth lines.

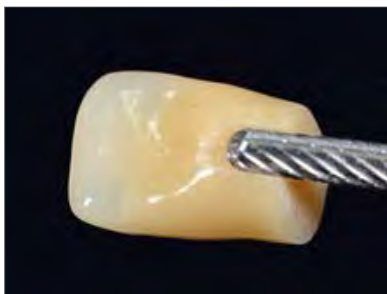
**Figure 16 a:** Inserting a retention recess in VITAPAN EXCELL® using a tungsten carbide cutter

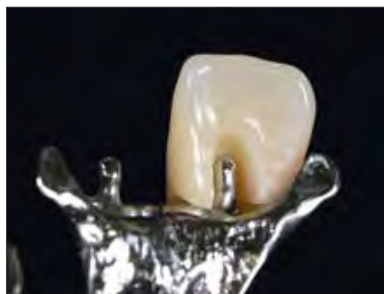
**Figure 16 b:** Positioning the prepared VITAPAN EXCELL® on the CoCr framework
